Painting White Trim on the Jones House in Pontiac

By: Dale C. Maley

Last Updated: August 26, 2023

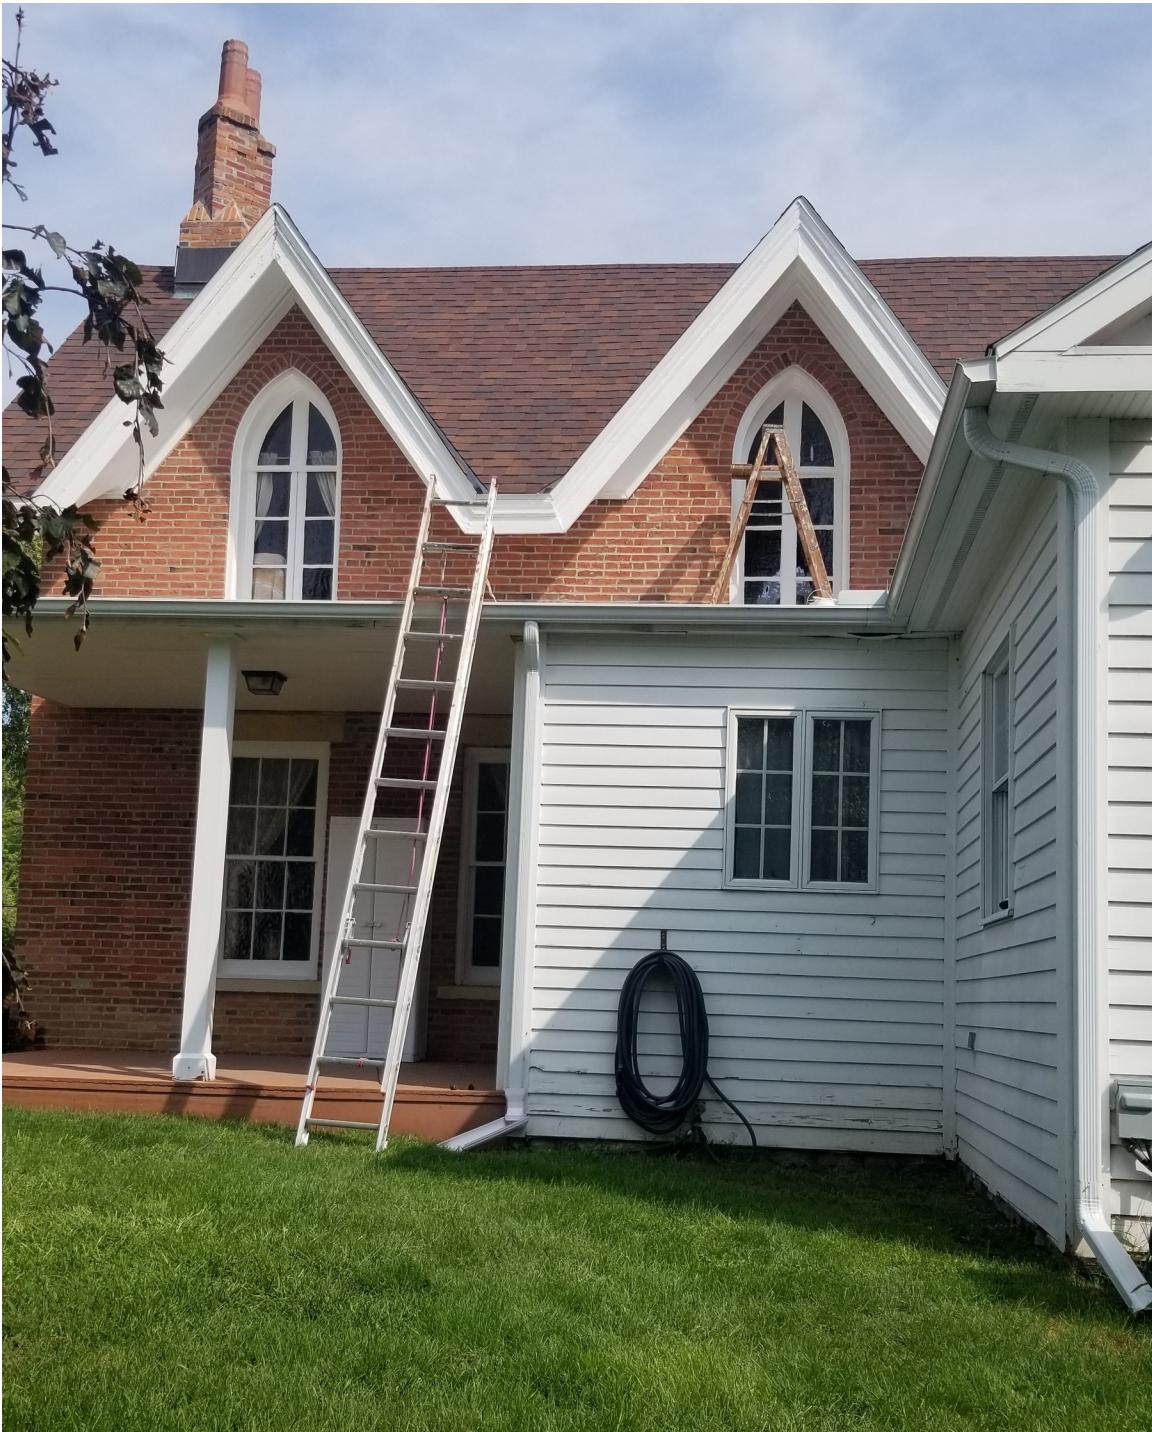
Extension ladder to get to south porch roof, then wood stepladder on the roof

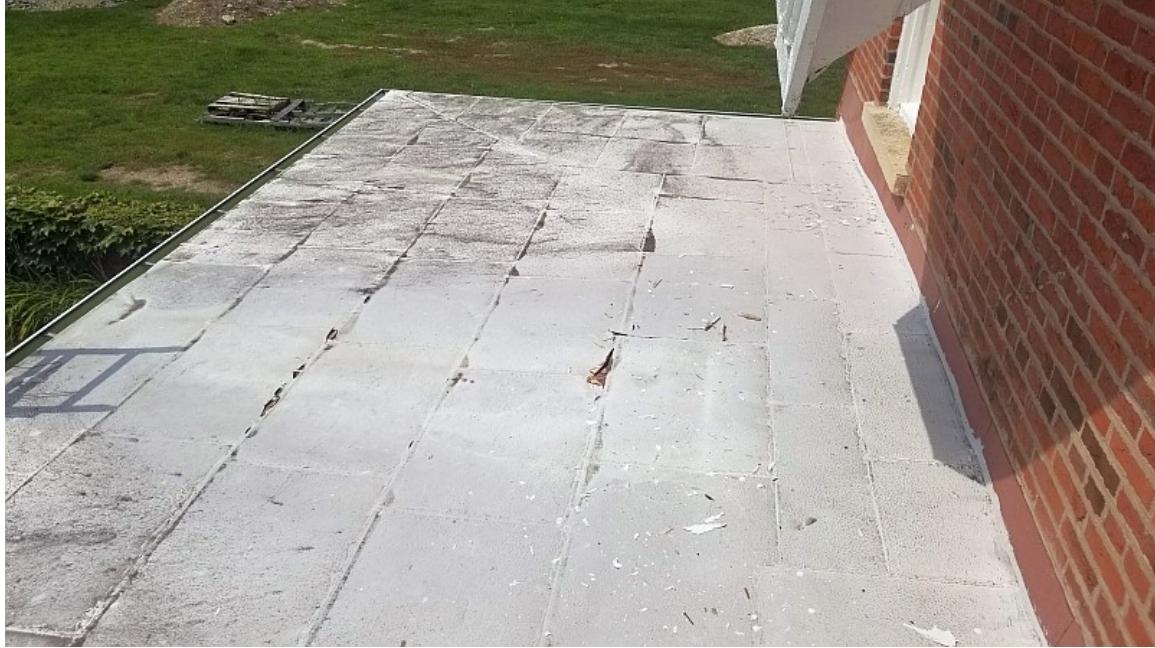
The coating on the tin on the south porch roof is separating from the tin. Fairbury Ace has the thick white coating that you roll on. The dirt needs cleaned from the roof before it is recoated. Maybe a whisk broom dipped in soapy water, then rinsed with a hose would do it.....versus lifting a pressure washer onto the roof?

South porch roof, coating is separating from tin, also dirt on roof

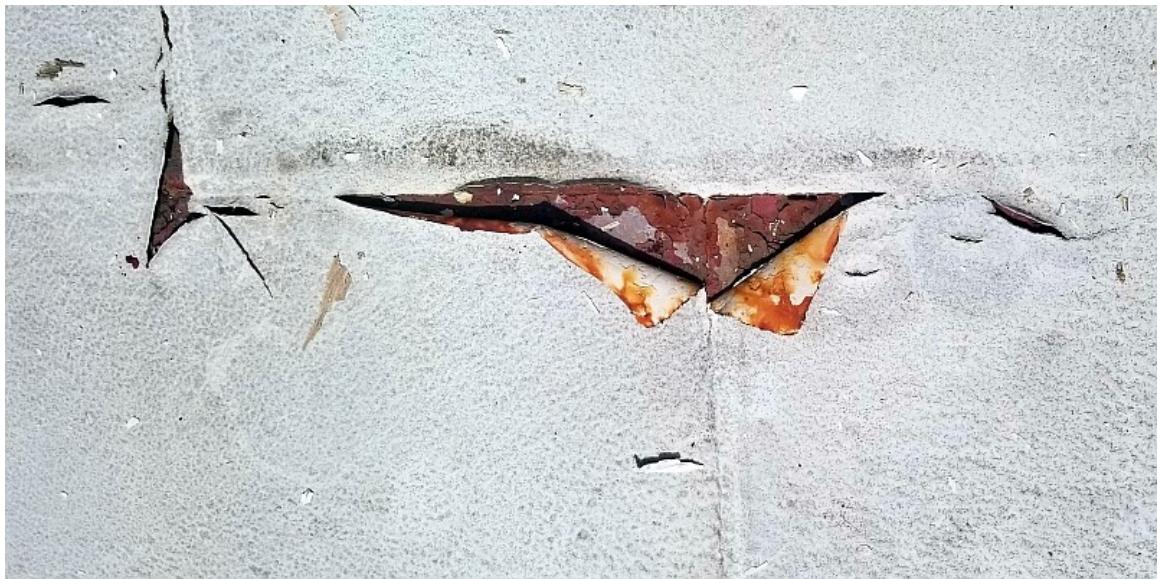
Worst spot on south porch roof

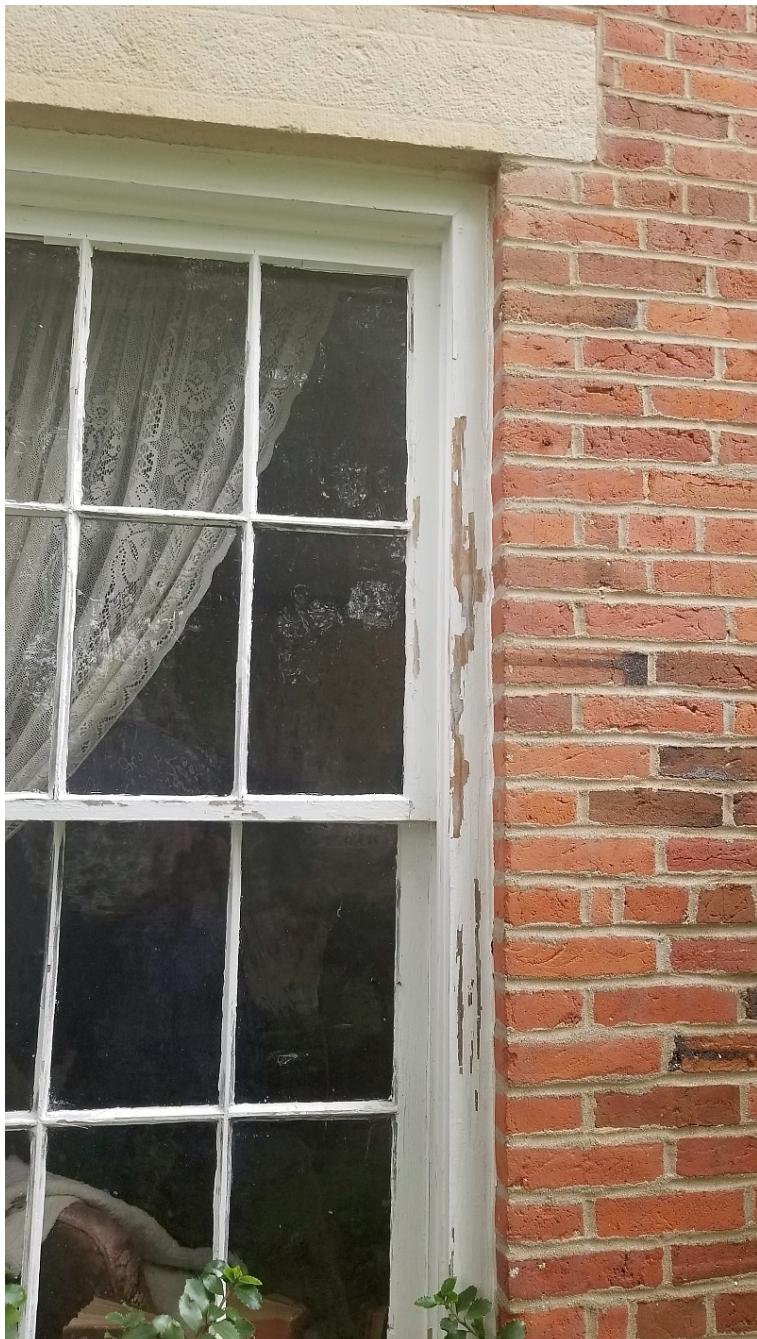
East window before painting

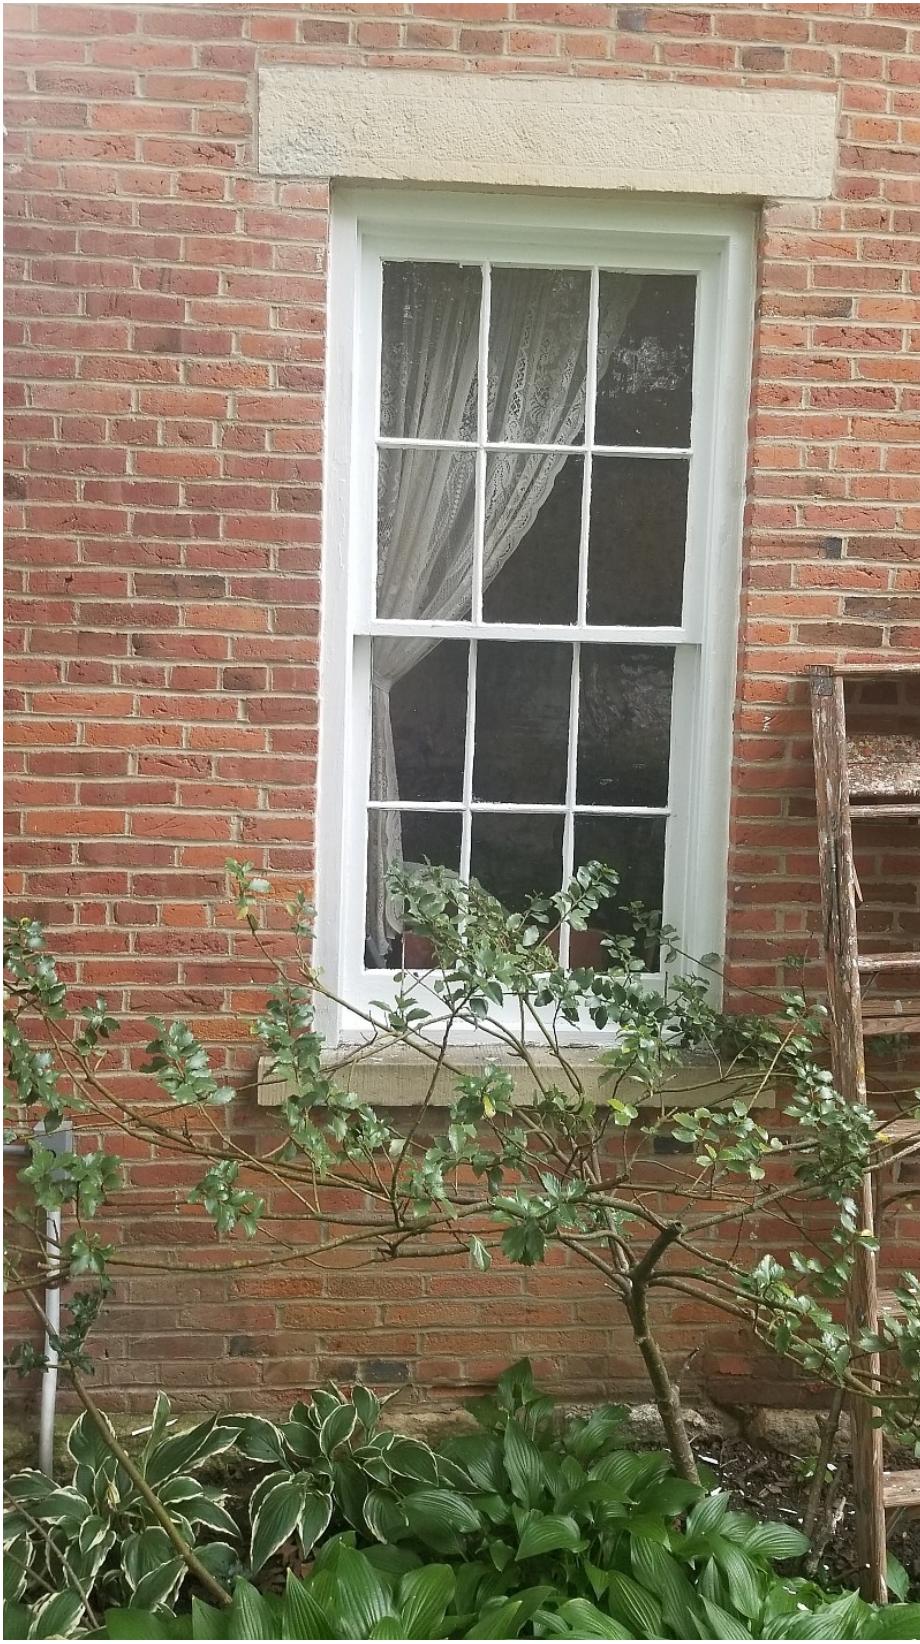
East window after painting and fixing glazing

I started first by putting 2 coats on all the 1st story windows. On all windows, the bottom sill board gets the most weather and rain, peels first, and rots first. Each window had some spots where the glazing had fallen out or was ready to fall out. I got some new DAP glazing at Fairbury Ace. I swear that when I was a kid on our farm in the 1960s, I could roll the new glazing in both hands, making a string I laid onto the mullion, then used a putty knife to smooth the glazing parallel to the mullion. The 2023 new glazing would not stay put against the mullions. I ended up putting a little new glazing on the end of the small black putty knife, then forcing it into place against the mullion with a 45 degree angle. I sometimes smoothed the marks between putty knife marks with my finger. This method worked ok.
